FINAL REPORT
R335-01

**INVESTIGATION OF THE SHIELDING BEHAVIOR
OF TWO PIPELINE COATING SYSTEMS**

POLYGUARD PRODUCTS, INC.
ENNIS, TEXAS

MARCH 2001

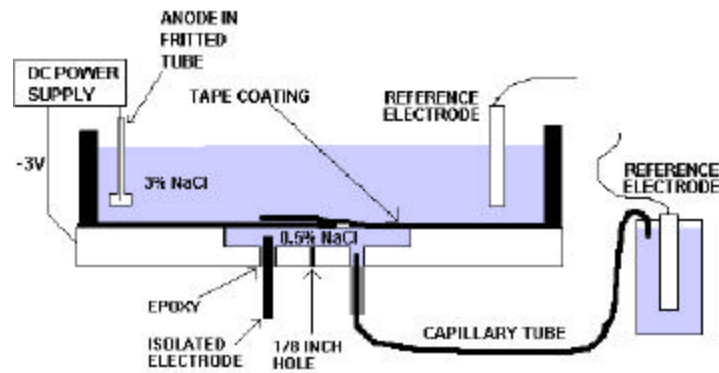
Figure 1. A schematic of the setup used for each of the 4 cells.

Four different test cells were set using the supplied test cells, Polyguard 600 primer, and the two different coatings (RD-6 and 610). A cut-away diagram of the setup is shown in Figure 1. A photo of the basic cell setup is shown in Figure 2.

Cell A consisted of RD-6 coating system with no existing lap joint over the void. Also, the primer was not applied to the area within the void. (Does CP pass directly through the tape?)

Cell B consisted of RD-6 coating system with a one-inch lap joint over the void and again no primer was applied to the area within the void. (If it cannot pass through the tape in (A), does it pass through the lap joint?)

Cell C consisted of RD-6 coating system with a one-inch lap joint over the void; however the primer was applied to the area within the void. (With minimal surface area to protect under the lap joint, is there still evidence of CP passing?)

Cell D consisted of 610 tape coating with a one-inch lap joint over the void and no primer was applied in the area within the void. (Does a lap joint in the standard polyethylene tape also allow CP current?)

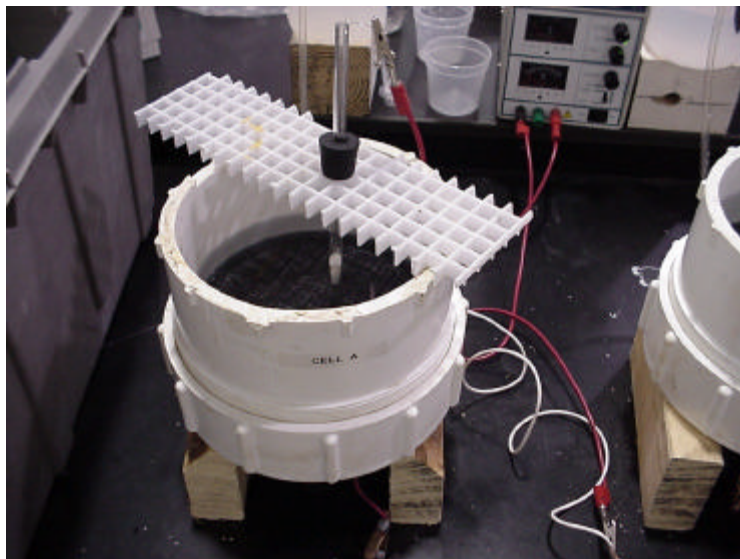
Figure 2. The setup of Task 1 showing Cell A attached to a power supply. And this is how it will look for 2 or more lines of a detailed caption.

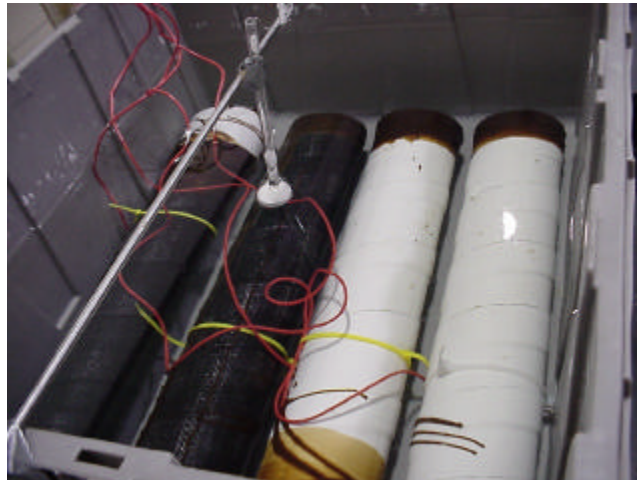
Figure 3. The four 18-inch long, 3 inch diameter pipes coated in either RD-6 or 610 coatings and submerged in 3% NaCl solution for Task 2.

1. Each of the four 18-inch long, 3-inch diameter carbon steel pipes had 4 grooves (~1/8" deep) machined into them using a Dremel tool.
2. The pipes were abrasive blasted with black beauty abrasive medium to obtain a near white finish with an anchor profile of 2 to 4 mils.
3. An insulated copper lead wire was cad-welded onto each of the pipes.
4. The pipes were de-greased using methanol.
5. Two of the four pipes were primed using the supplied Polyguard 600 primer. Primer was not allowed to coat the inside of the machined grooves.

A photograph of the setup for Task 2 can be seen in Figure 3.

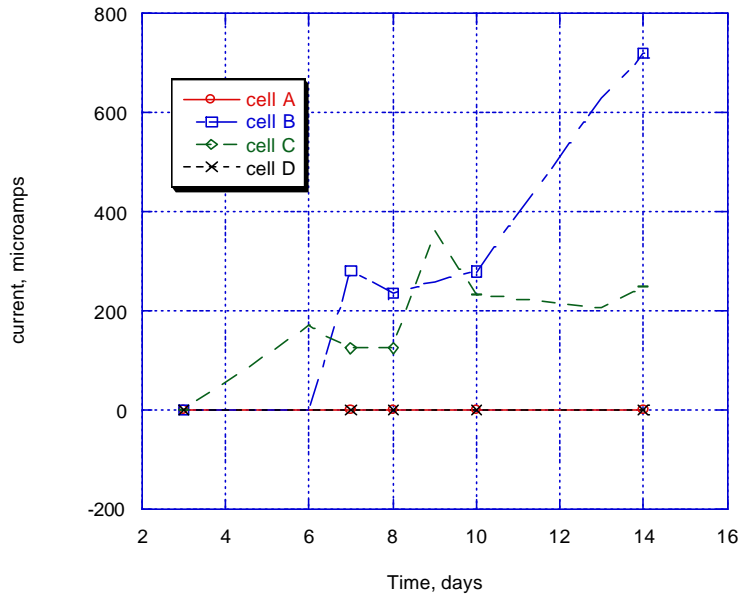
Figure 4. Current readings as a function of time through different tape joints.

A plot of the amount of current evidenced is shown in Figure 4.

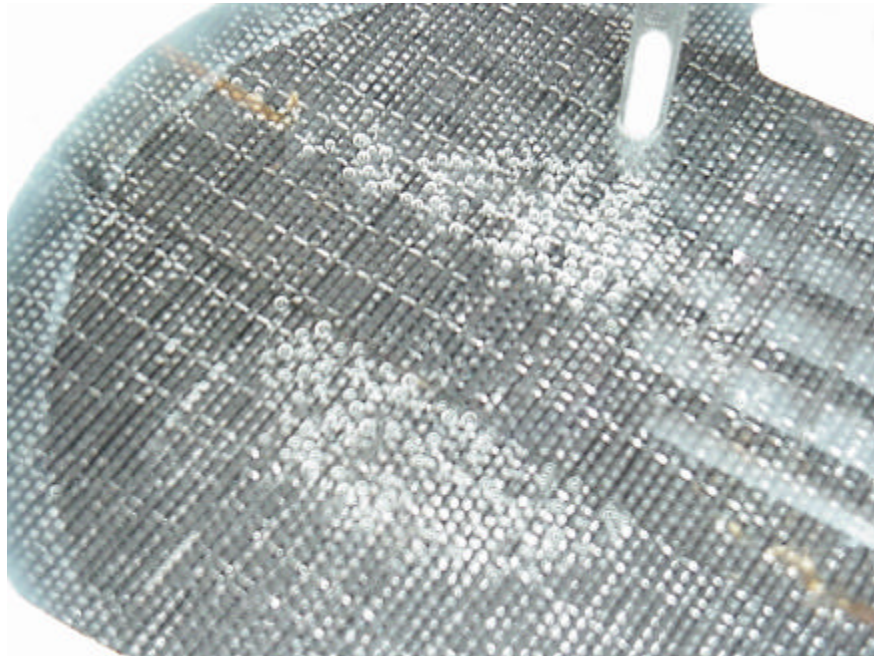
Figure 5. Bubbles framing the lap joint region over the void in Cell B.

Bubbles appeared on the surface of the tape in Cell B, which did not have the void primed and was coated with RD-6 system (see Figure 5). Presumably this was hydrogen outgassing due to the cathodic reaction at the surface. The combination of high surface area of the unprimed void and the successful application of CP to this void resulted in the excessive amount of hydrogen production which was evidenced. In the sample where the void was primed, the smaller surface area for the cathodic reaction on the steel resulted in less hydrogen being produced, thus bubbles were not evident.

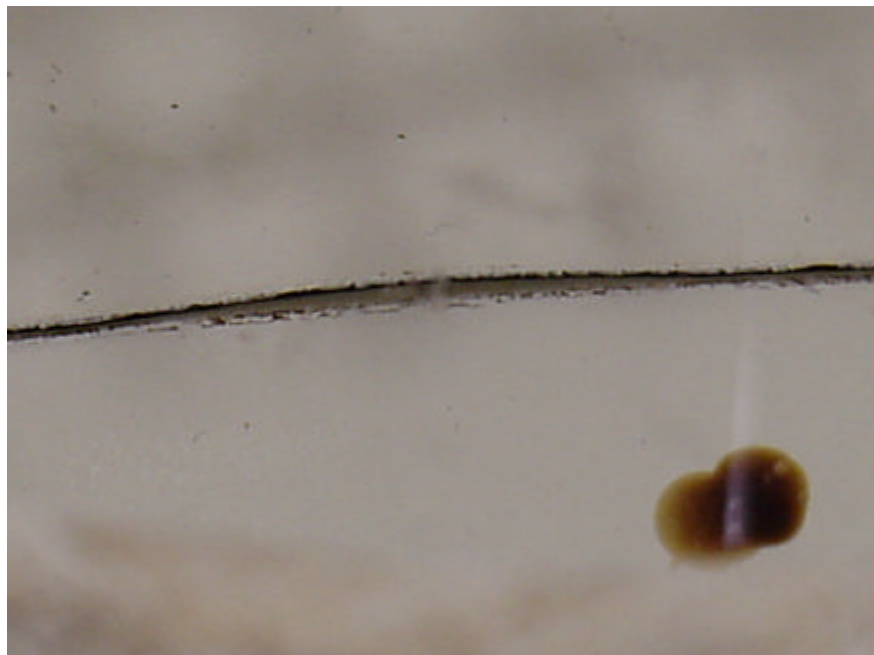
Figure 6. The lap joint in Cell D coated with 610 tape, showing partial joint separation.

The lap joint in the 610 tape (Task 1 activity only) began to separate late in the test (see Figure 6). Since the coating application over the flat test specimen did not allow for the proper spiral tension, as would be present if the coating were properly wrapped around a pipe, more pressure or weight for a longer period of time may have been required to provide a better seal. However, this did not appear to cause any leakage when the data from Table 1d is examined.
